Case 280 : Narrative

Case Vehicle (A): 1999 Mazda
Type: MX5 Miata, 2-door convertible
Driver: 49-year-old male
CDC: 12-FCEN-3

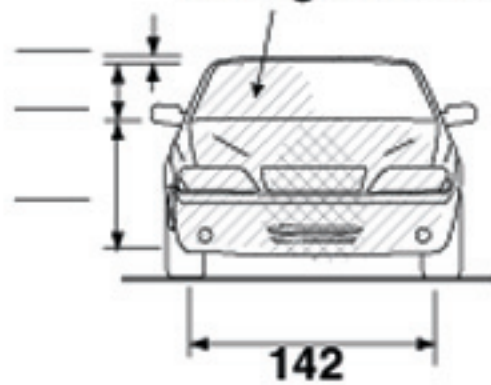
airbag cover contact

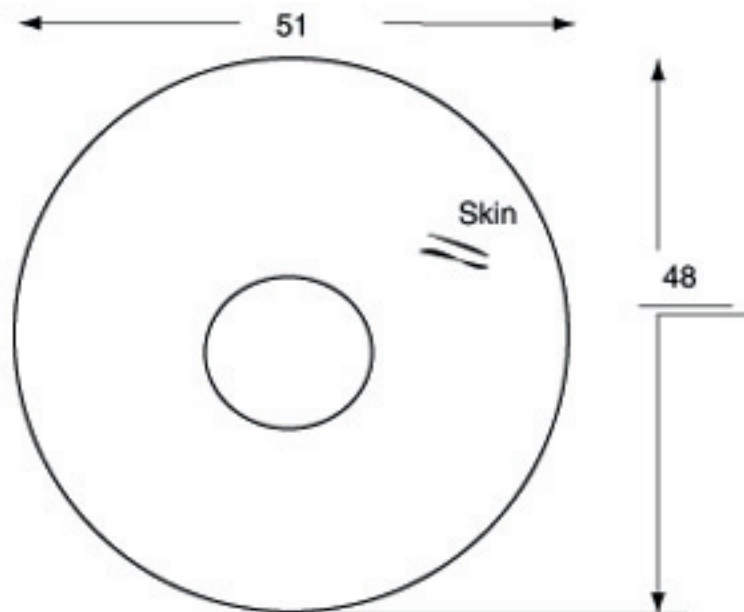
Driver Airbag

AIRBAG NUMBER ON DRIVER SIDE: T056

Vents: ☒ Y ☐ N
If yes, how many: 2

Tethers: ☒ Y ☐ N
If yes, how many: 1

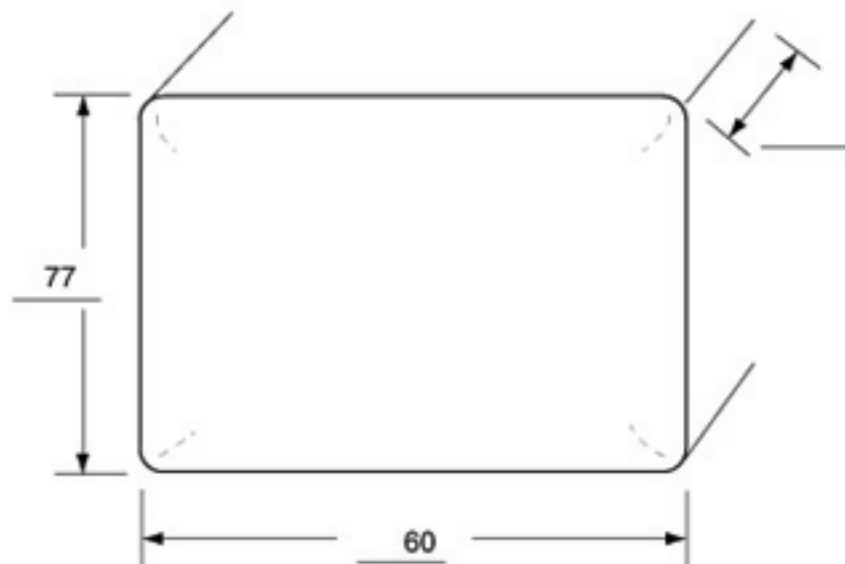
Passenger Airbag

Airbag Number on Passenger Side: BBN21984ES982775060398

Vents: ☒ Y ☐ N
if yes, how many: 2

Tethers: Y ☒ N
if yes, how many:
